# Naval Facilities Engineering Command

NAVFAC MO-102.2

## Maintenance & Repair Alternatives Pavement Condition Index (PCI) Field Manual November 1988

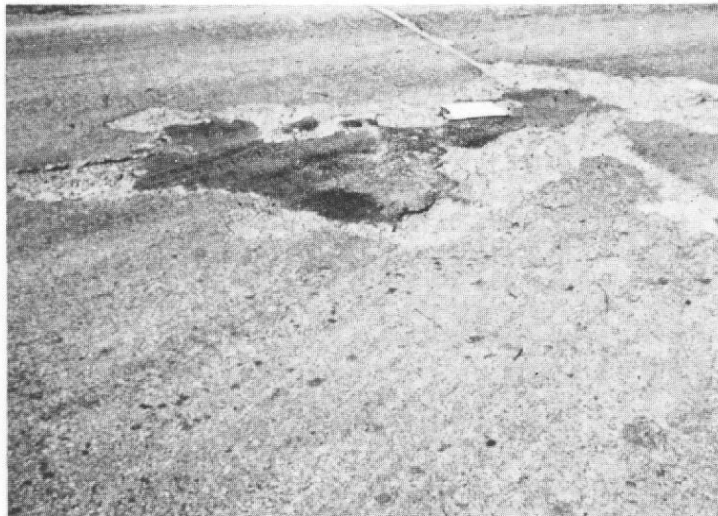
Figure 73. Distress in jointed concrete pavements

1. Faulting is counted only at joints. Faulting associated with cracks is not counted separately since faulting is incorporated into the severity-level definitions of cracks. Crack definitions are also used in defining corner breaks and divided slabs.
2. Joint seal damage is not counted on a slab-by-slab basis. Instead, a severity level is assigned based on the overall condition of the joint seal in the area.
3. Cracks in reinforced concrete slabs that are less than 1/8 in. wide are counted as shrinkage cracks. Shrinkage cracks should not be counted to determine if the slab is broken into four or more pieces.
4. If the original distress of a patch is more severe than the patch, the original distress is the distress type recorded. For example, although patch material is present on the scaled area of the slab illustrated in Figure 73, only the scaling is counted.

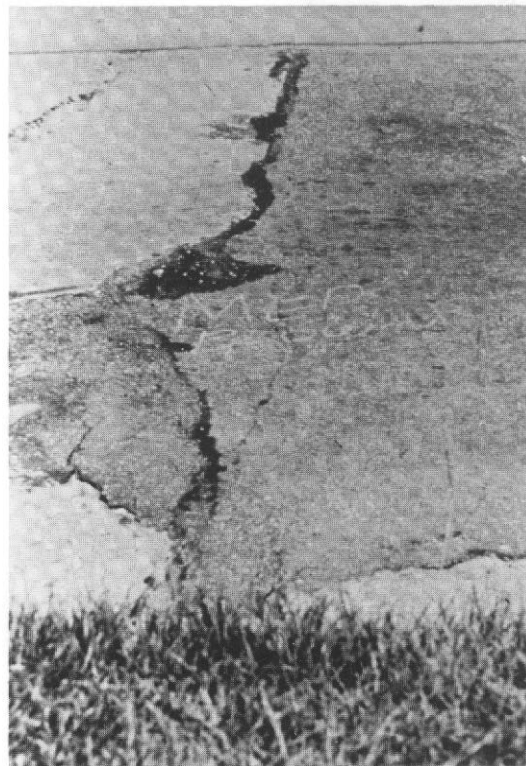
**Figure 75.** Medium-severity blow-up/buckling

M - Buckling or shattering causes medium-severity ride quality. (Figures 75 and 76)

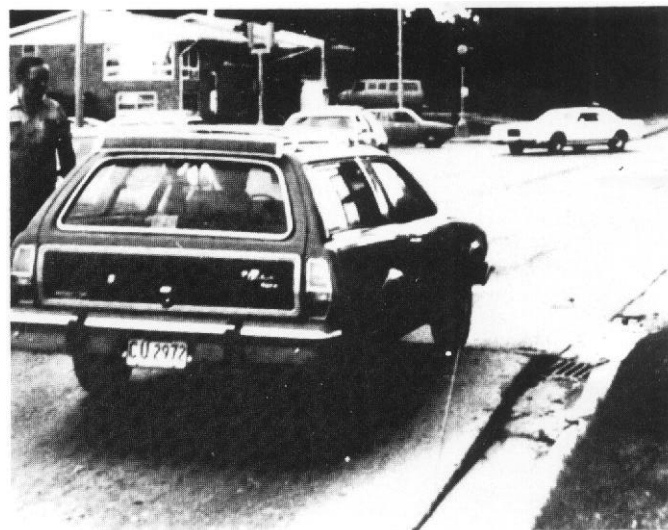
Figure 77. High-severity blow-up/buckling approaching inoperative condition

H - Buckling or shattering causes high-severity ride quality. (Figure 77)

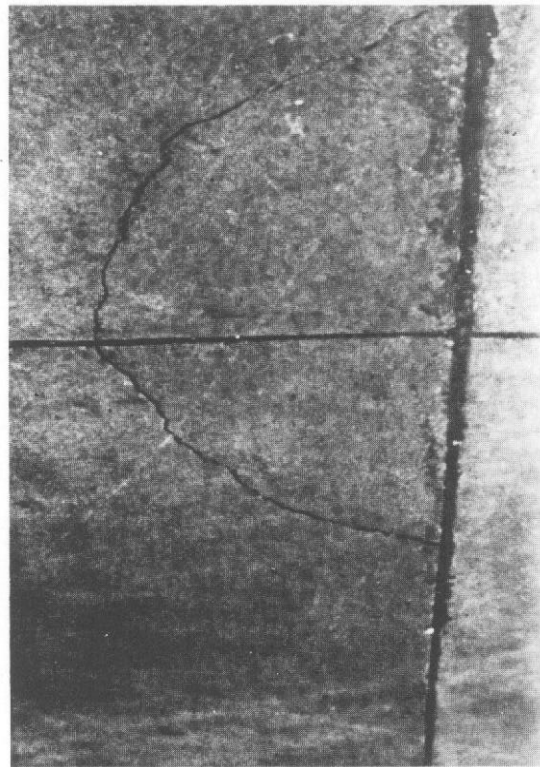
Figure 79. Low-severity corner break

L - Break is defined by a low-severity crack\* and the area between the break and the joints is not cracked or may be lightly cracked. (Figures 78 and 79)

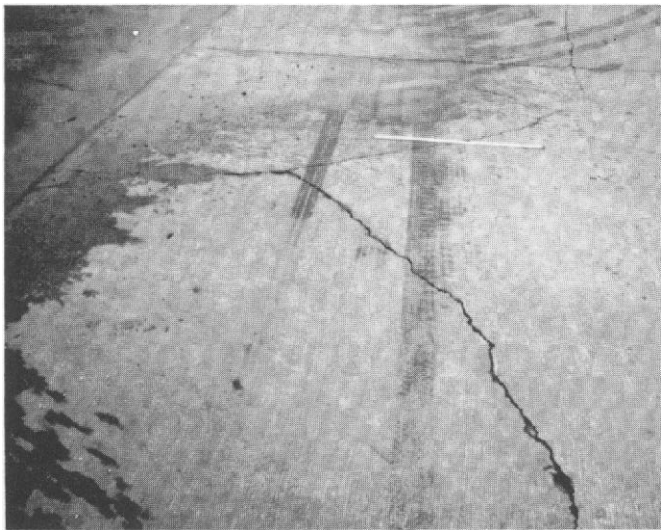
Figure 82. Low-severity divided slab. Majority of cracks are low severity (less than 1/2 in. wide and no faulting).

How to Count: See Figures 82 through 86.  
If the slab is medium or high severity, no other distress is counted.

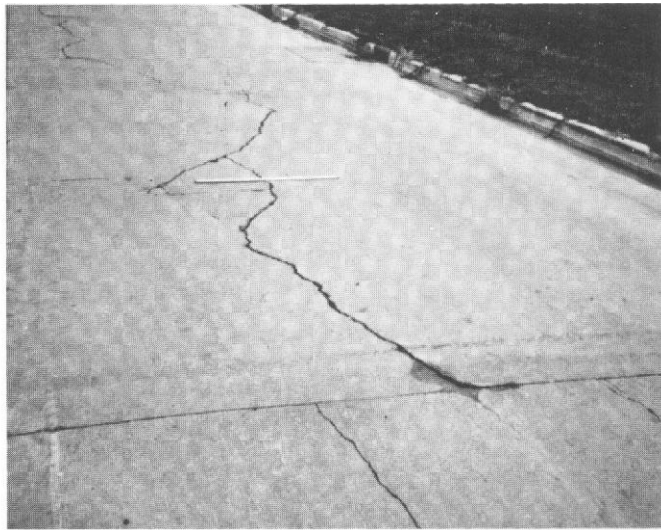
Figure 83. Medium-severity divided slab

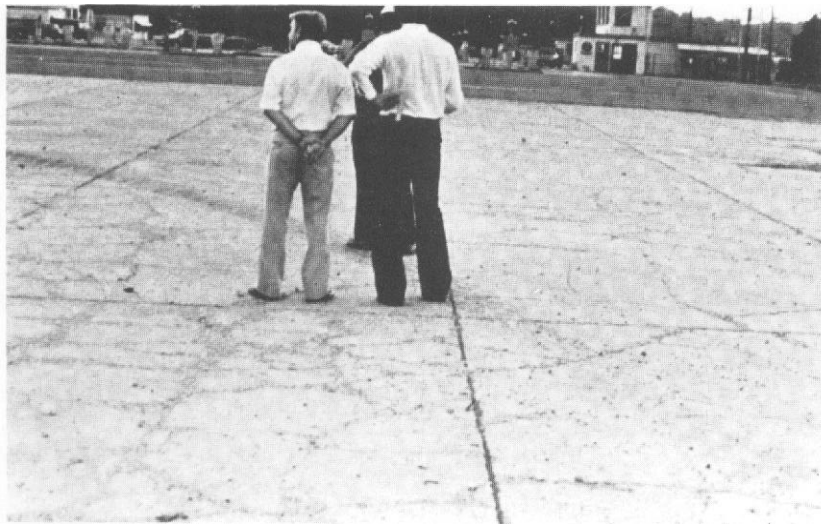
Figure 86. High-severity divided slab

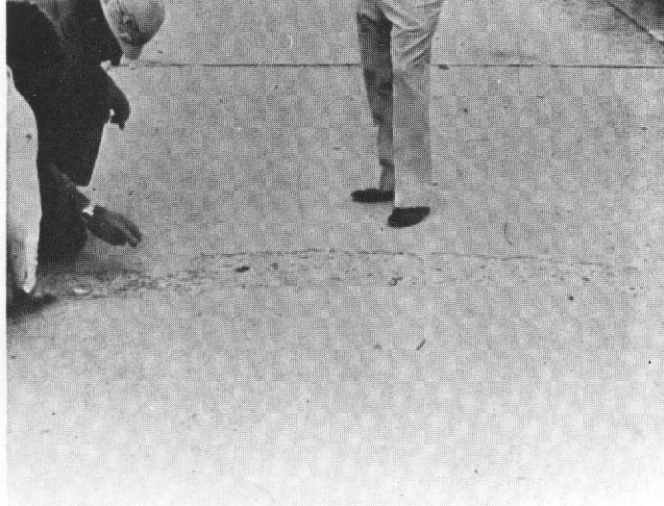
Figure 89. Medium-severity durability cracking

M- One of the following conditions exist (Figure 89):

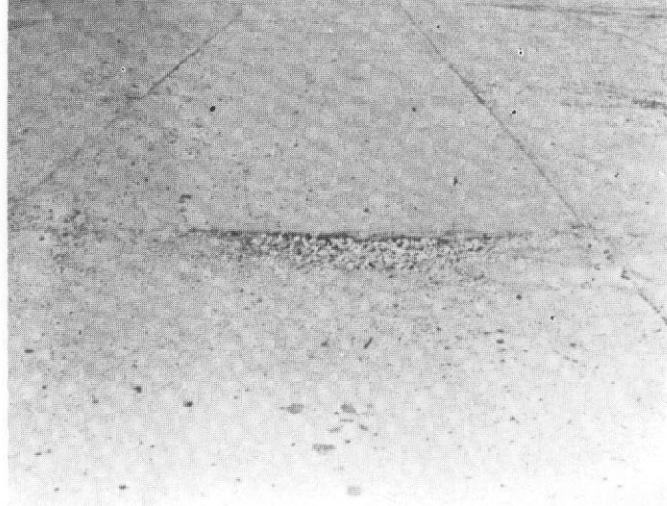
Figure 90. High-severity durability cracking

H - "D" cracks cover more than 15 percent of the area and most of the pieces have popped out or can be easily removed. (See Figures 90 and 91)

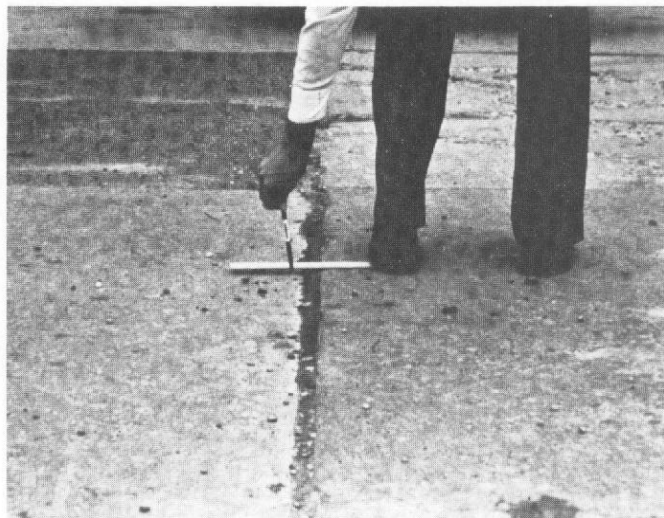
**Figure 93.** Medium-severity faulting

See Figures 92 through 95.

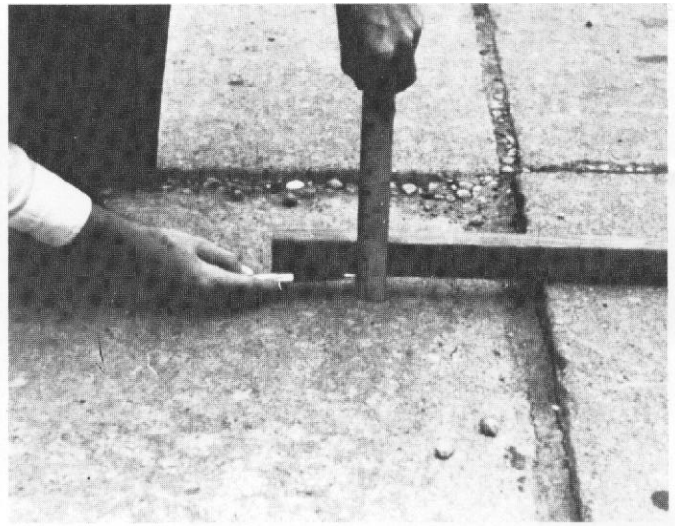
Figure 95. High-severity faulting

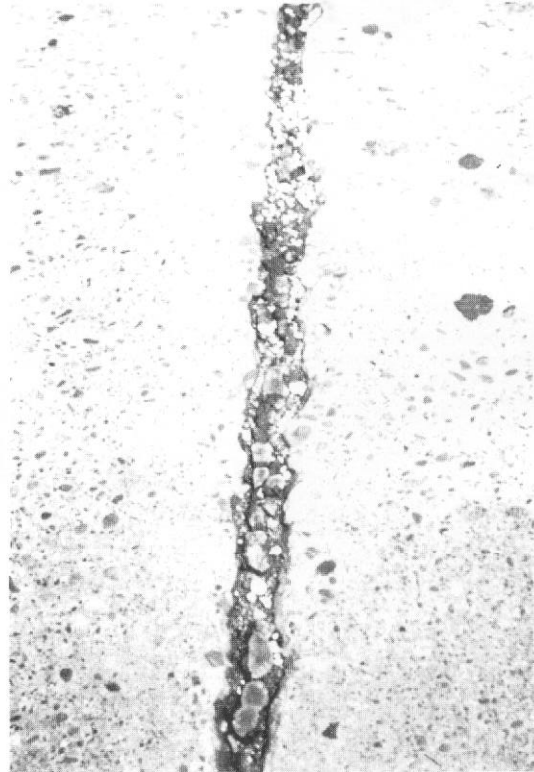
Figure 99. High-severity joint seal damage

H - Joint sealant is in generally poor condition over the entire section, with one or more of the above types of damage occurring to a severe degree. Sealant needs immediate replacement. (Figures 98 and 99)

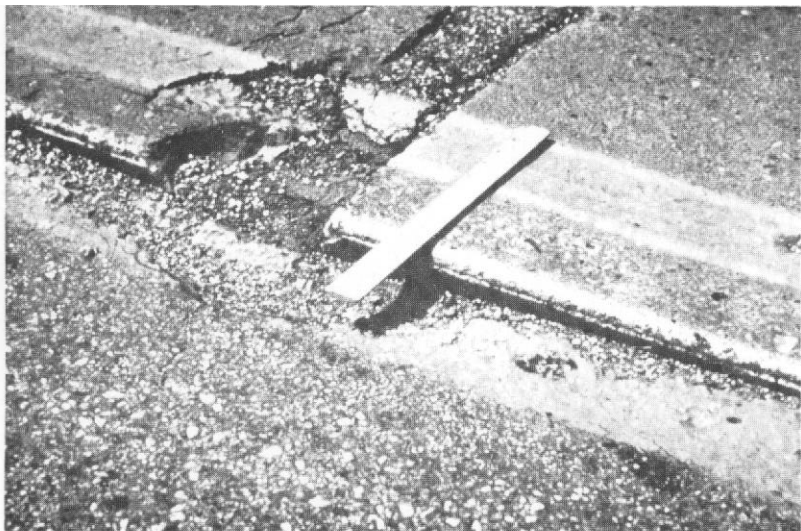
Figure 100. Low-severity lane/shoulder drop off

Levels: L - The difference between the pavement edge and shoulder is 1 to 2 in. (25 to 51 mm). (Figure 100)

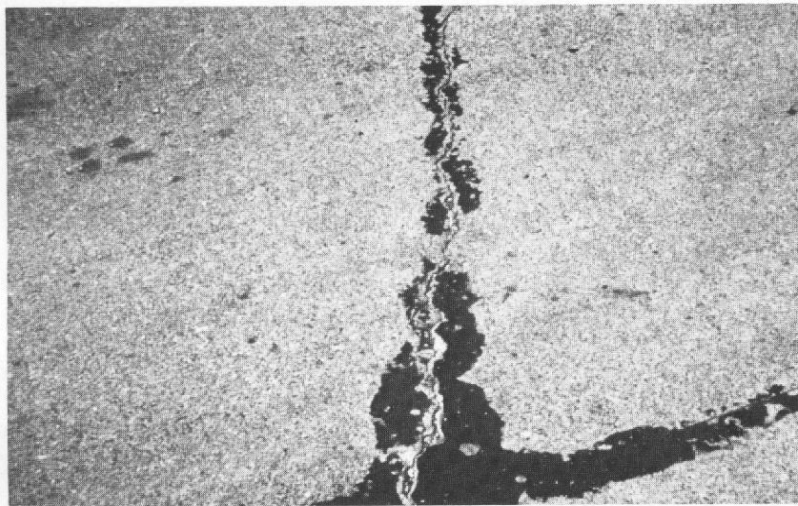
**Figure 103.** Low-severity linear cracking in a nonreinforced concrete slab.

Description: These cracks, which divide the slab into two or three pieces, are usually caused by a combination of repeated traffic loading, thermal gradient curling, and repeated moisture loading. (Slabs divided into four or more pieces are counted as Divided Slabs.) Low-severity cracks are usually related to warp or friction and are not considered major structural distresses. Medium- or high-severity cracks are usually working cracks and are considered major structural distresses. (Figures 103 through 108)

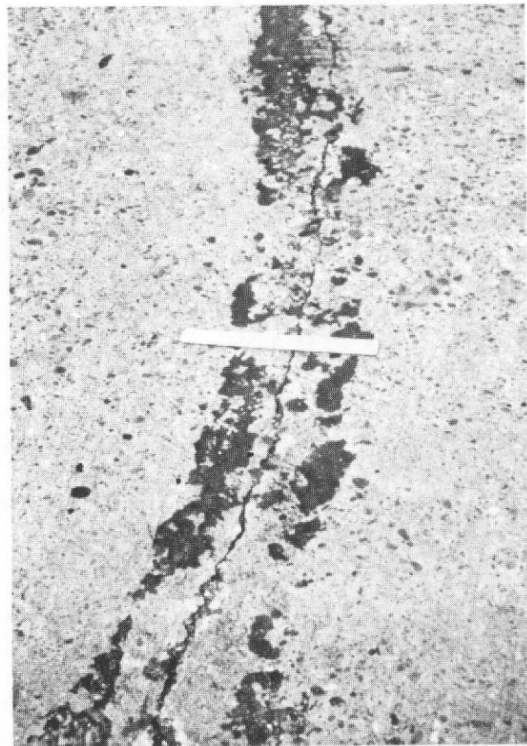
**Figure 104.** Low-severity linear cracking in a nonreinforced concrete slab

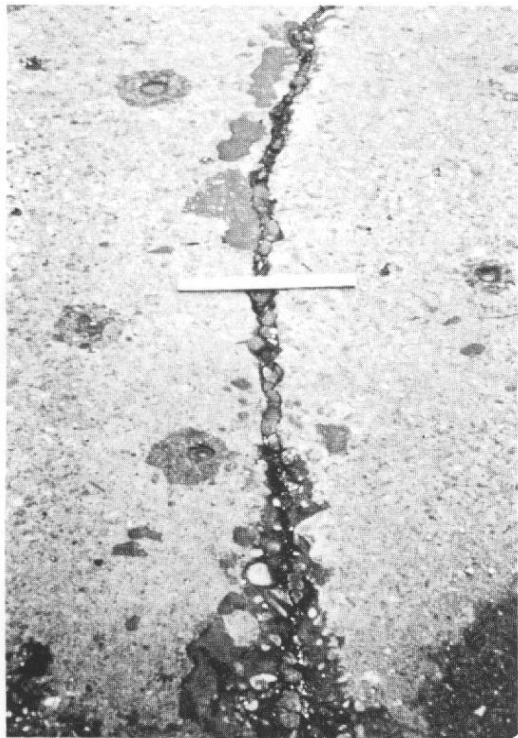
Figure 105. Medium-severity linear cracking in a reinforced concrete slab

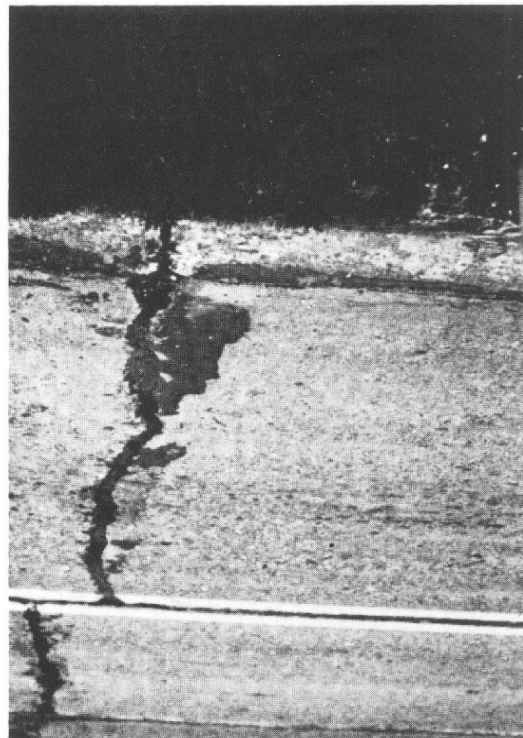
Figure 106. Medium-severity linear cracking in a reinforced concrete slab

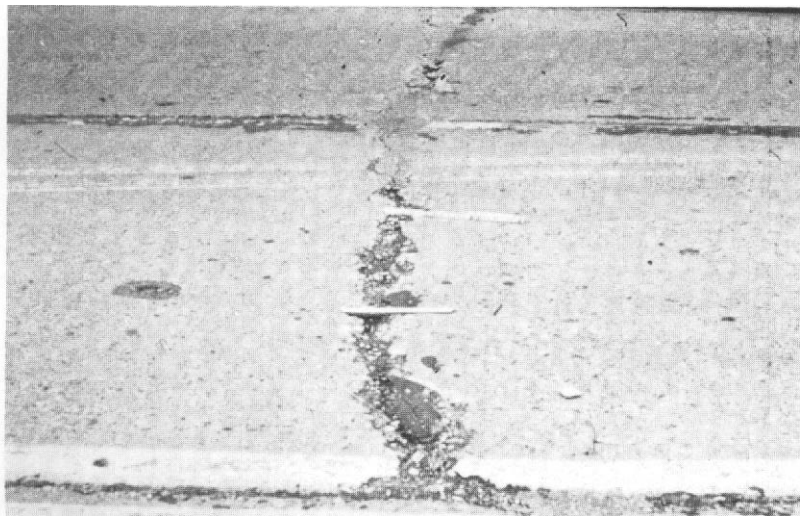
Figure 107. High-severity linear cracking in a nonreinforced concrete slab

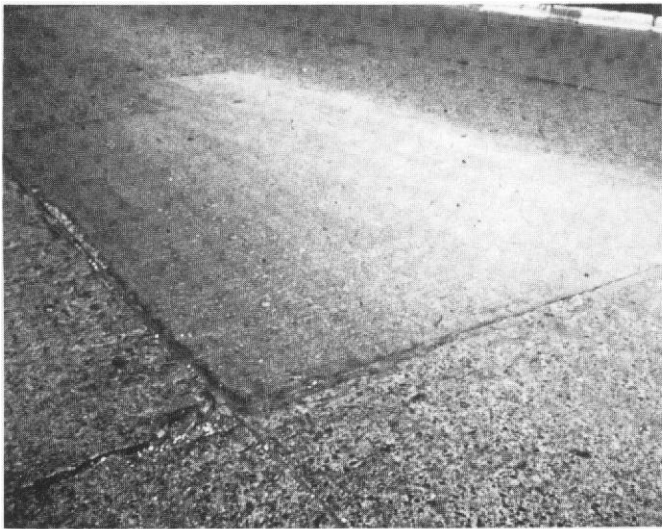
Figure 109. Low-severity patching, large and utility cuts

L - Patch is functioning well, with little or no deterioration. (Figures 109 and 110)

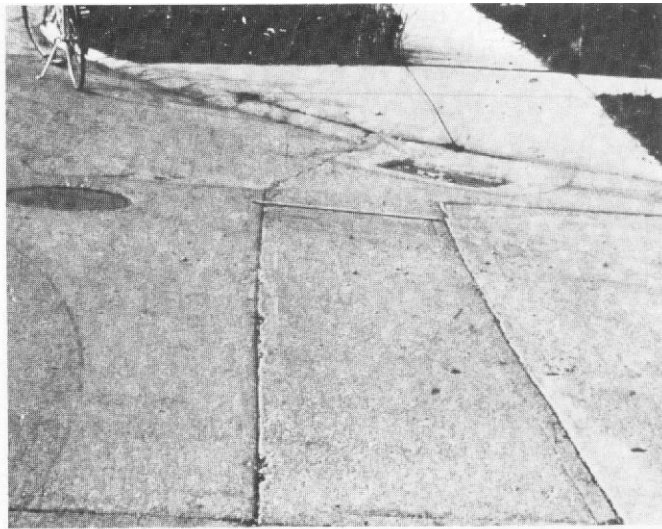
Figure 110. Low-severity patching, large and utility cuts

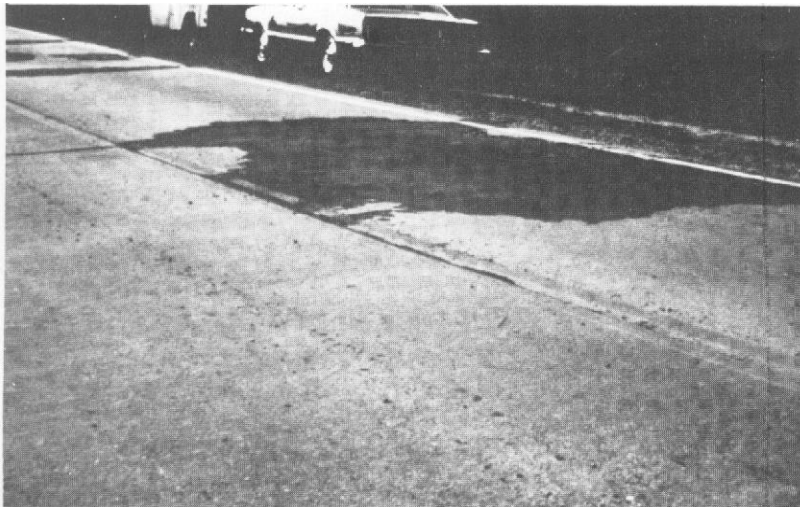
Figure 111. Medium-severity patching, large

M - Patch is moderately deteriorated and/or moderate spalling can be seen around the edges. Patch material can be dislodged with considerable effort. (Figures 111 through 113)

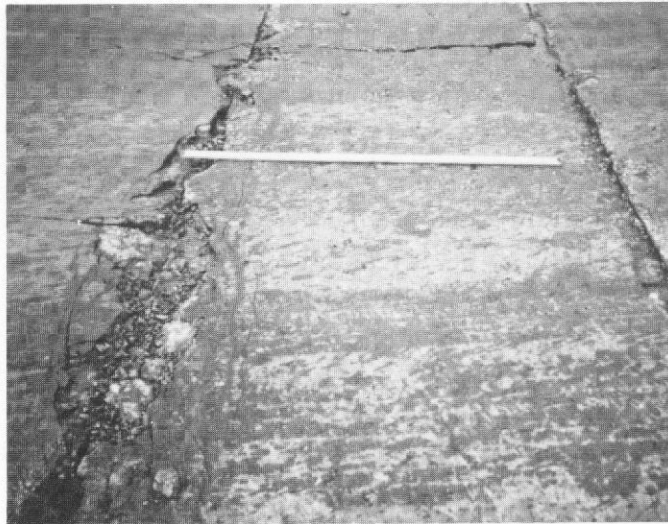
Figure 114. High-severity patching. large

H - Patch is badly deteriorated. The extent of the deterioration warrants replacement of the patch. (Figure 114)

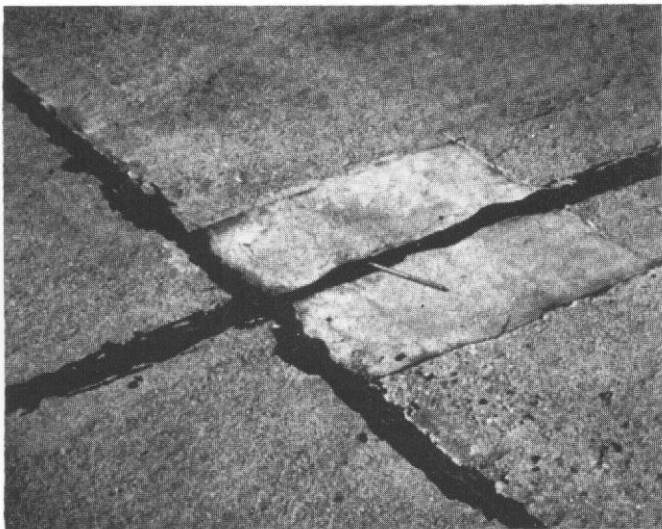
Figure 115. Low-severity patching, small

Levels: L - Patch is functioning well with little or no deterioration. (Figure 115)

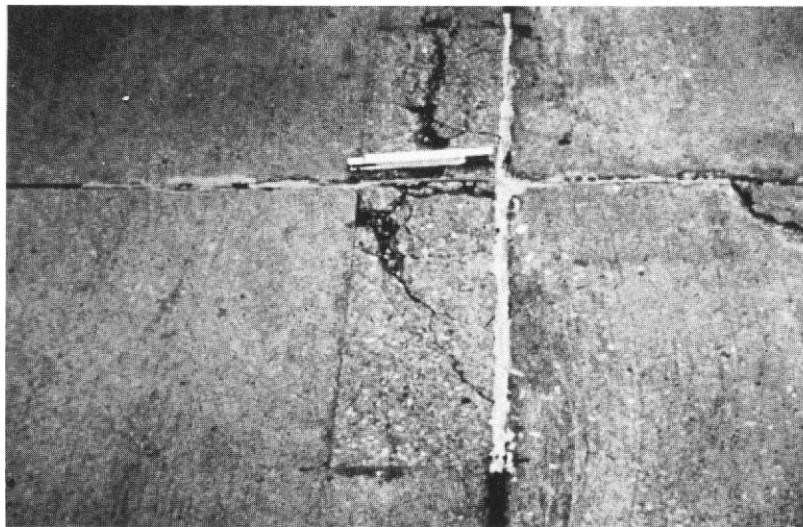
Figure 117. High-severity patching, small

H - Patch is badly deteriorated. The extent of deterioration warrants replacement of the patch. (Figure 117)

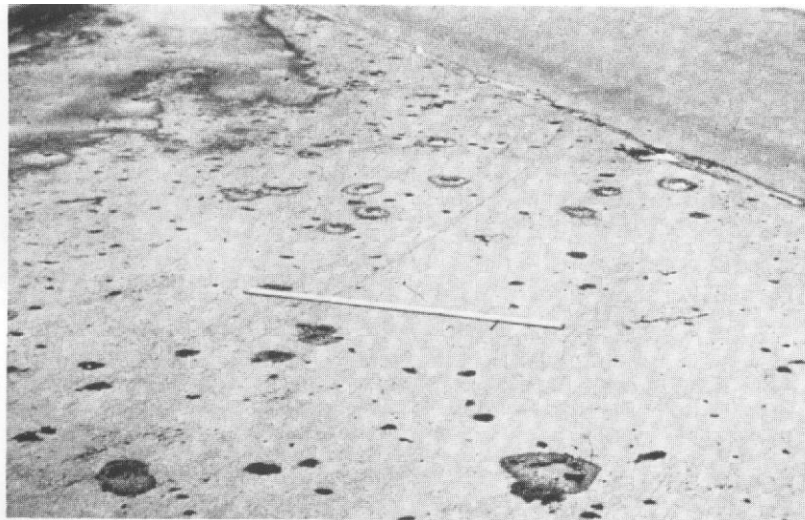
Figure 119. Popouts

**Description:** A popout is a small piece of pavement that freeze-thaw action combined with aggregate expansion causes to break loose from the surface. Popouts usually range in diameter from approximately 1 to 4 in. (25 to 102 mm) and in depth from 1/2 to 2 in. (13 to 51 mm).

**Levels:** No degrees of severity are defined for popouts. However, popouts must be extensive before they are counted as a distress. Average popout density must exceed approximately three popouts per square yard over the entire slab area. (Figure 119)

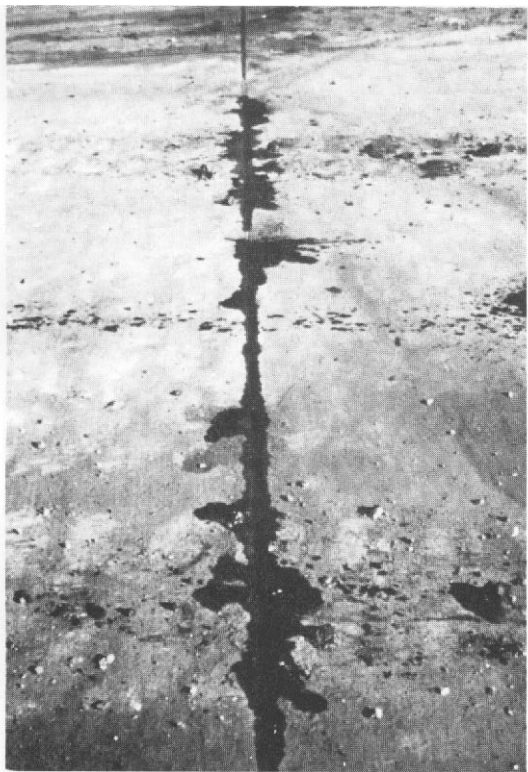
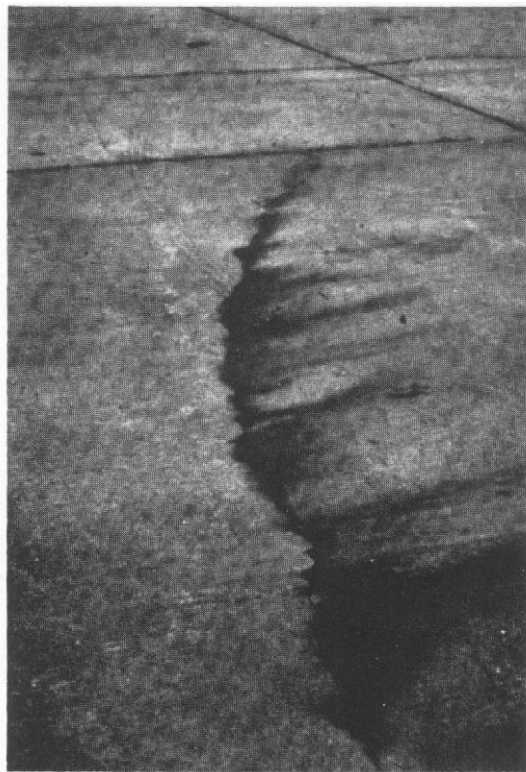
**Description:** Pumping is the ejection of material from the slab foundation through joints or cracks. This is caused by deflection of the slab by passing loads. As a load moves across the joint between the slabs, water is first forced under the leading slab, and then forced back under the trailing slab. This erodes and eventually removes soil particles, resulting in progressive loss of pavement support. Pumping can be identified by surface stains and evidence of base or subgrade material on the pavement close to joints or cracks. Pumping near joints is caused by poor joint sealer and indicates loss of support; repeated loading will eventually produce cracks. Pumping can also occur along the slab edge, causing loss of support.

**Levels:** No degrees of severity are defined. It is sufficient to indicate the pumping exists. (Figures 120 and 121)

Figure 120. Pumping

Figure 121. Pumping

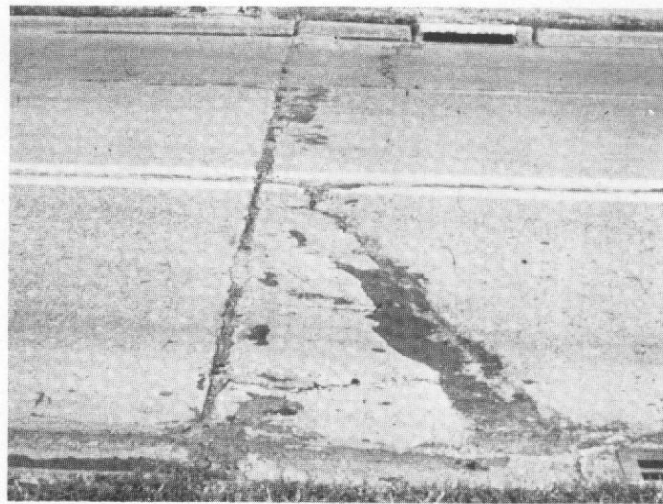
**Figure 123.** Medium-severity punchout approaching high severity

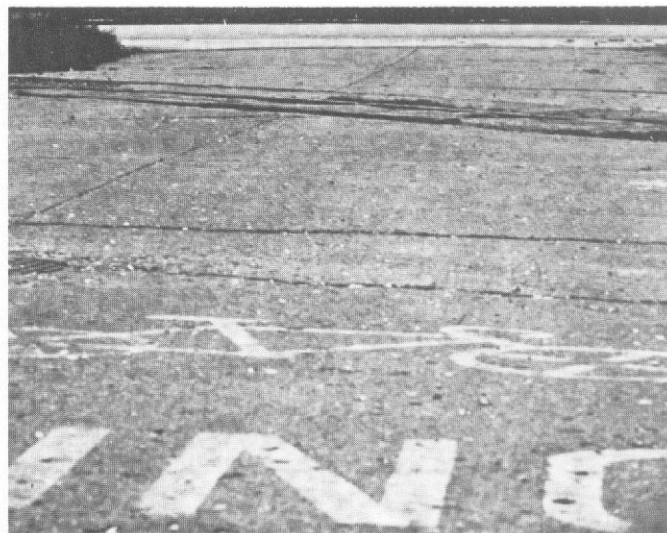
M - Railroad crossing causes medium-severity ride quality. (Figure 126)

Figure 126. Medium-severity railroad crossing

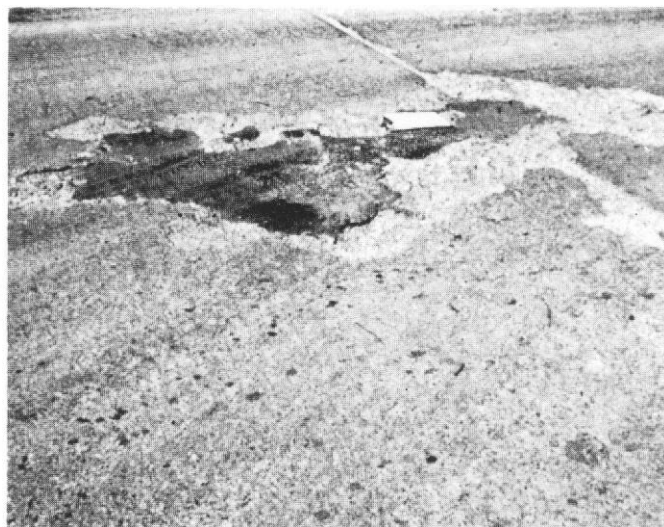
H - Slab is scaled over more than 15 percent of its area. (Figures 130 through 132)

Figure 130. High-severity scaling/map cracking/crazing

Figure 131. High-severity scaling/map cracking/crazing

Figure 132. High-severity scaling/map cracking/crazing

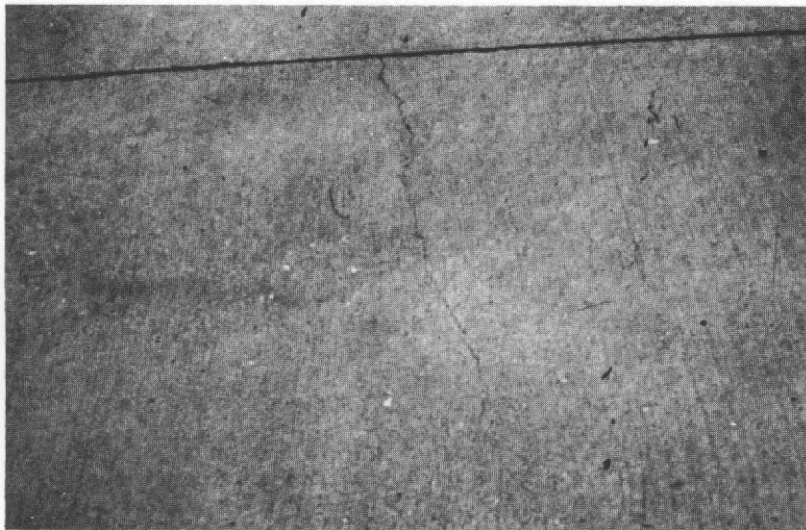
Levels: No degrees of severity are defined. It is enough to indicate that shrinkage cracks are present. (Figure 133)

**Figure 133.** Shrinkage cracks

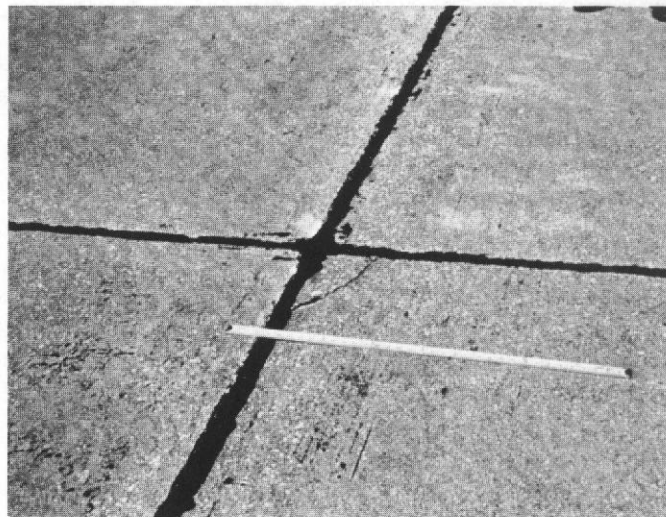
Corner spalling having an area of less than 10 sq in. (516 millimeters squared) is not counted. (Figures 134 through 137)

Figure 134. Low-severity spalling, corner

Figure 135. Low-severity spalling, corner

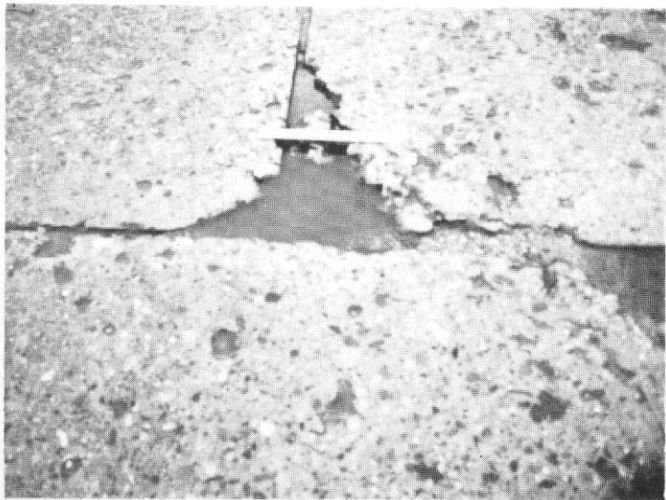
Figure 136. Medium-severity spalling, corner

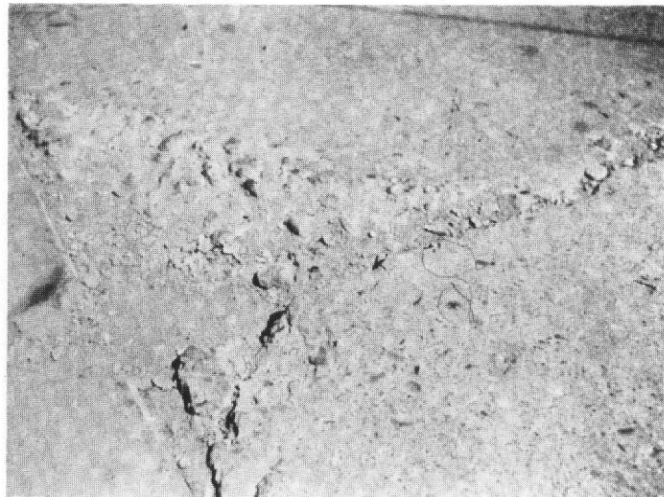
Figure 137. High-severity spalling, corner
